PV PANEL MADE IN CHINA

We bought some panels from our competitors in China. A small 30W panel with cut cells, a 100W panel with 32 cells and two 115 W panels (36 cells).

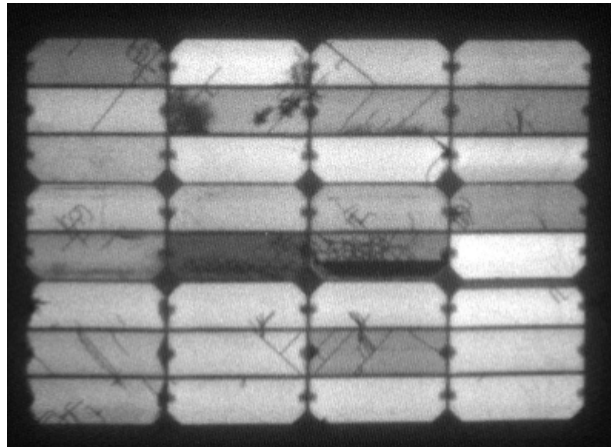
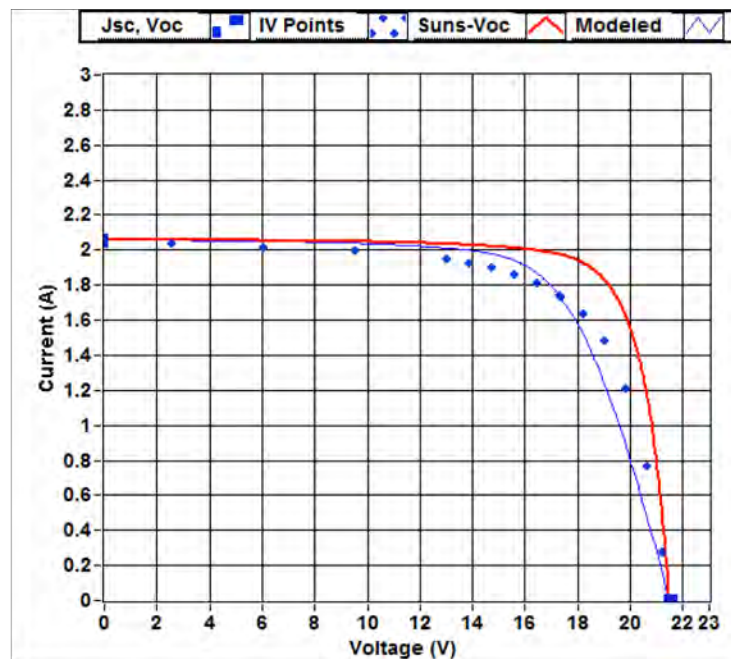
PV 30 EL TEST & FLASH TEST

Fill Factor = 68.12 %

$R_{sh} = 406.74 \text{ Ohms}$

Cells are cracked and marked. The total power is ok but the Fill Factor shows the problem. For SunPower grade A cells the Fill Factor should be close to 80%. Another problem is related to the poor R_{sh} (shunt resistance) measuring the presence of micro-shunts in the cells. The higher R_{sh} the better.

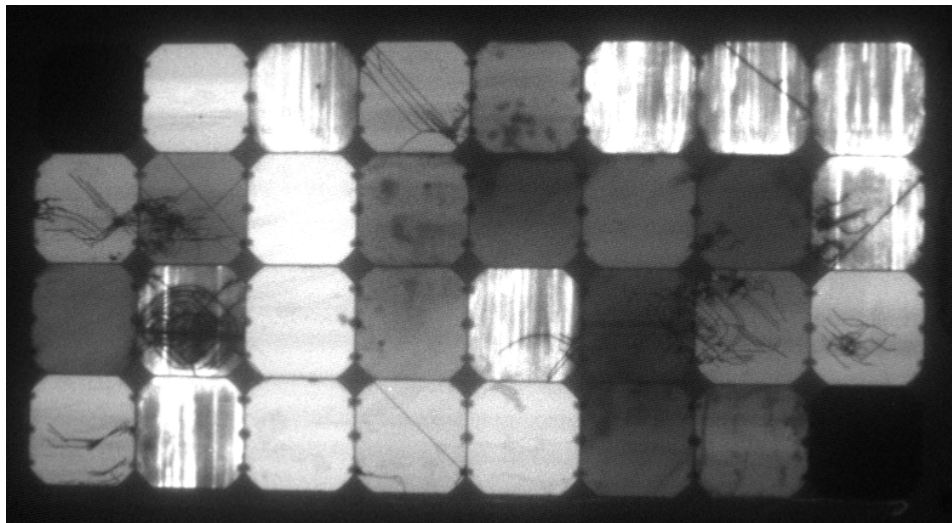
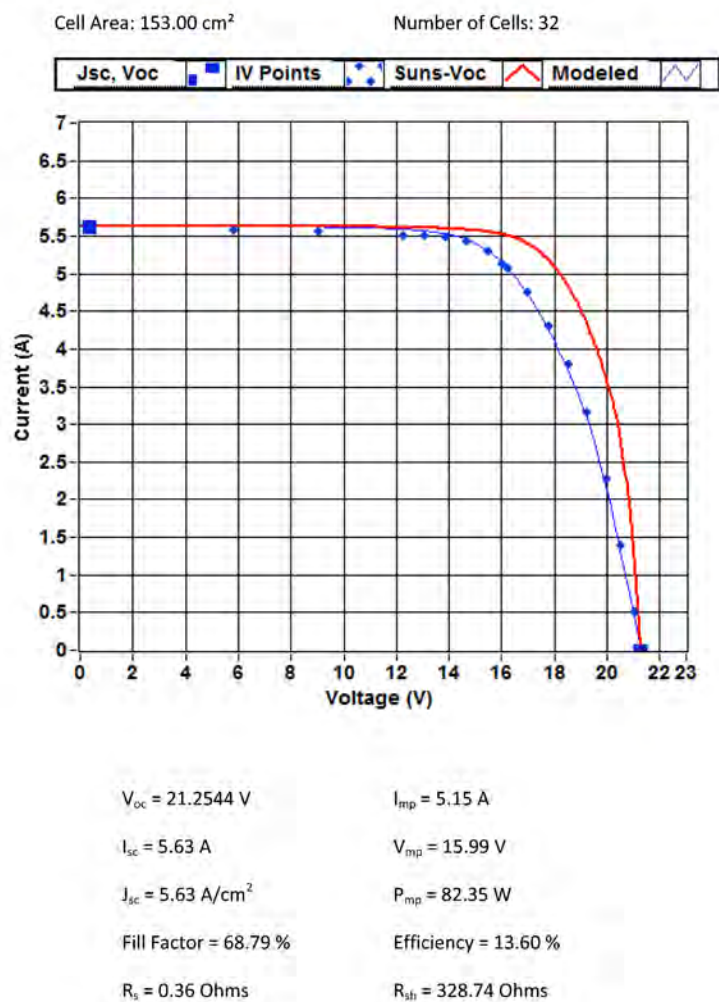
PV 100 EL TEST & FLASH TEST

Cells are severely cracked. Cell type is an old one. The total power is lower than declared.

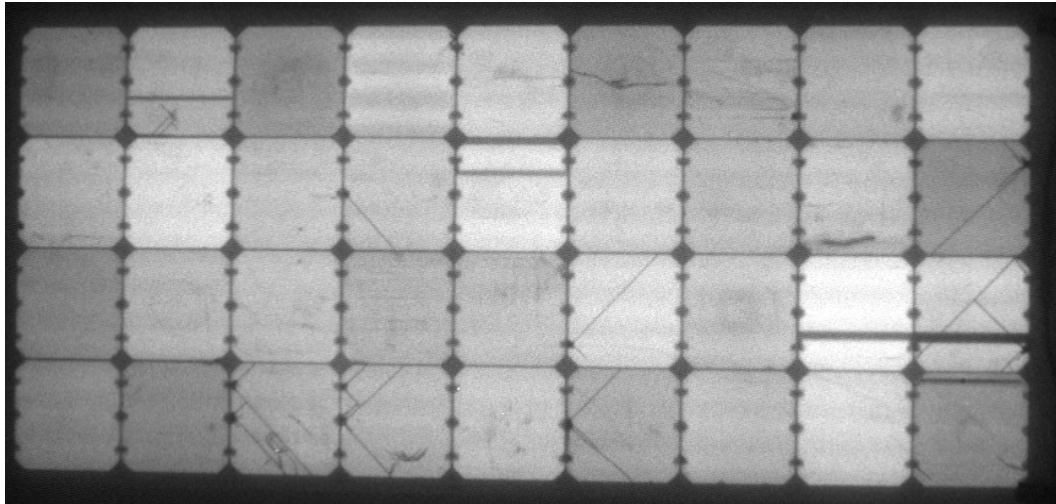
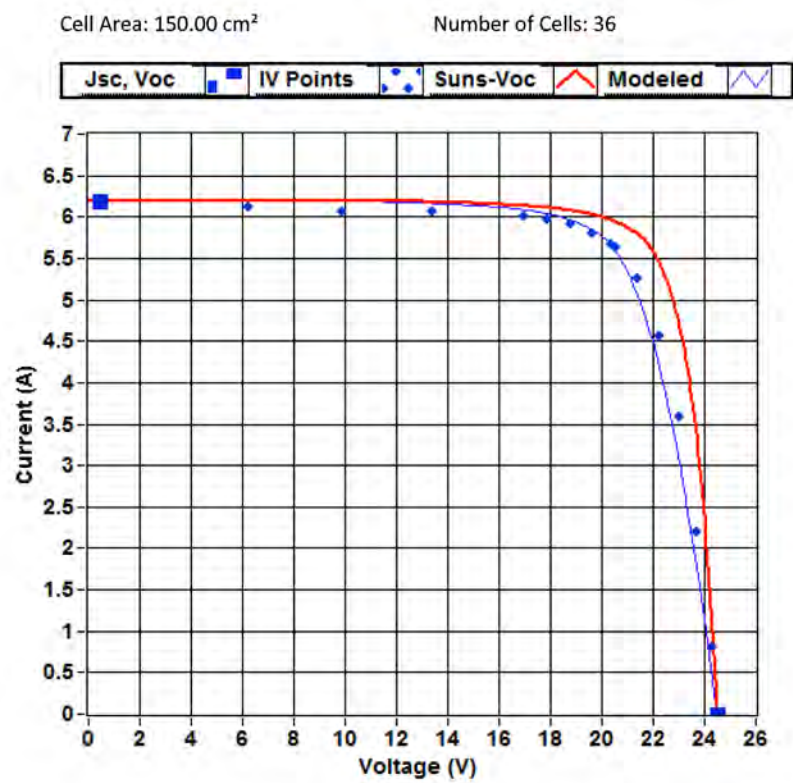
PV115_1 EL TEST & FLASH TEST

Cells show cracks and marks. The total power and Fill Factor are ok. Rsh is low.

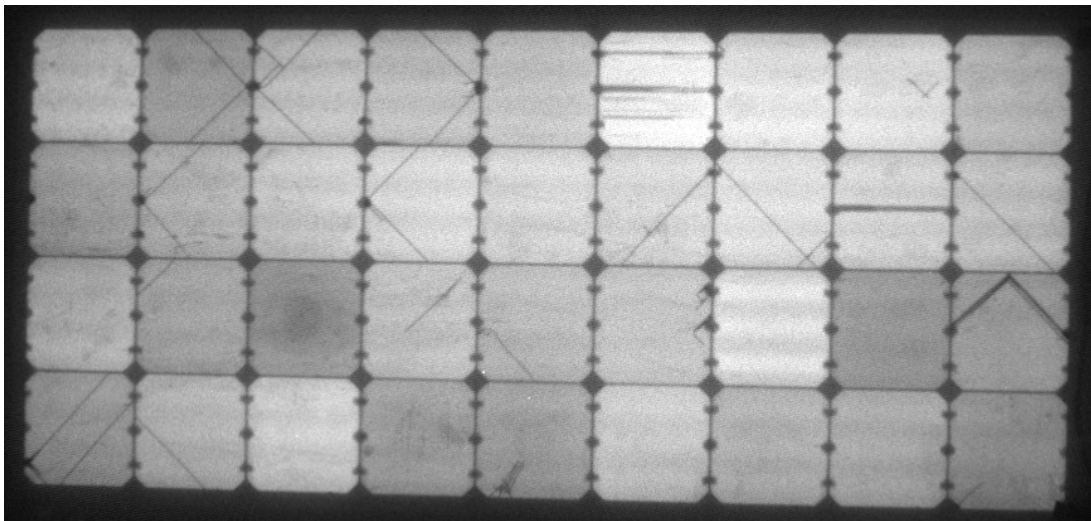
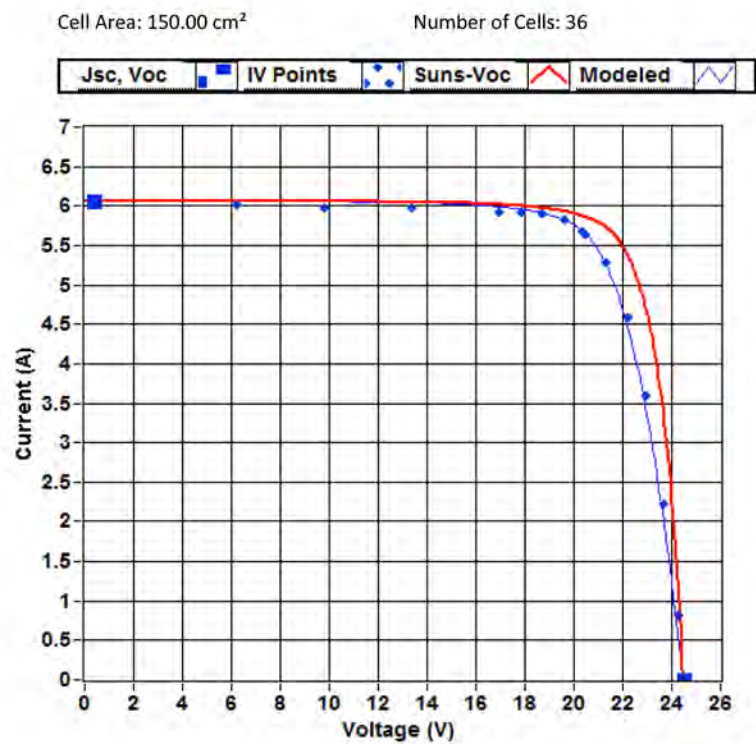
PV115_2 EL TEST & FLASH TEST

Cells show cracks and marks. The total power and Fill Factor are ok. Rsh is low.

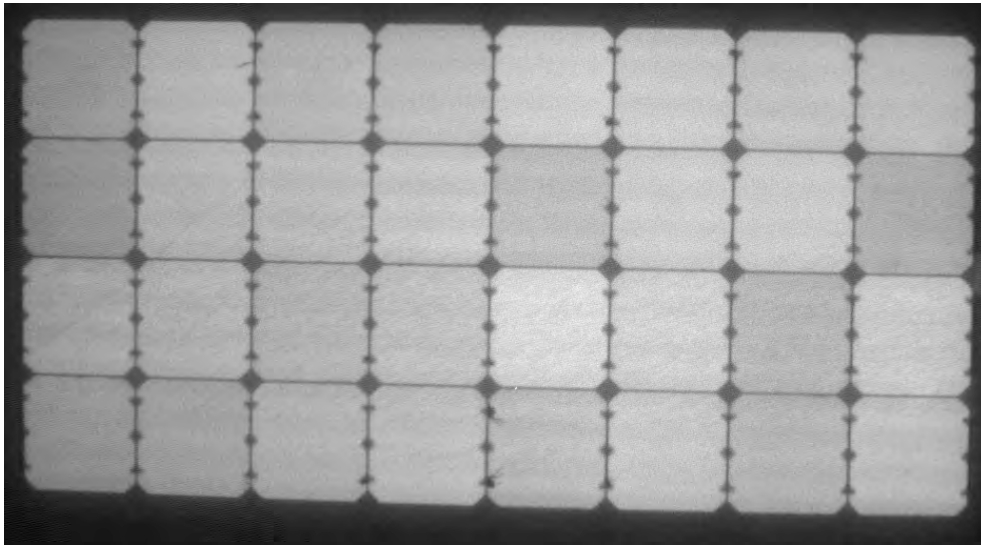
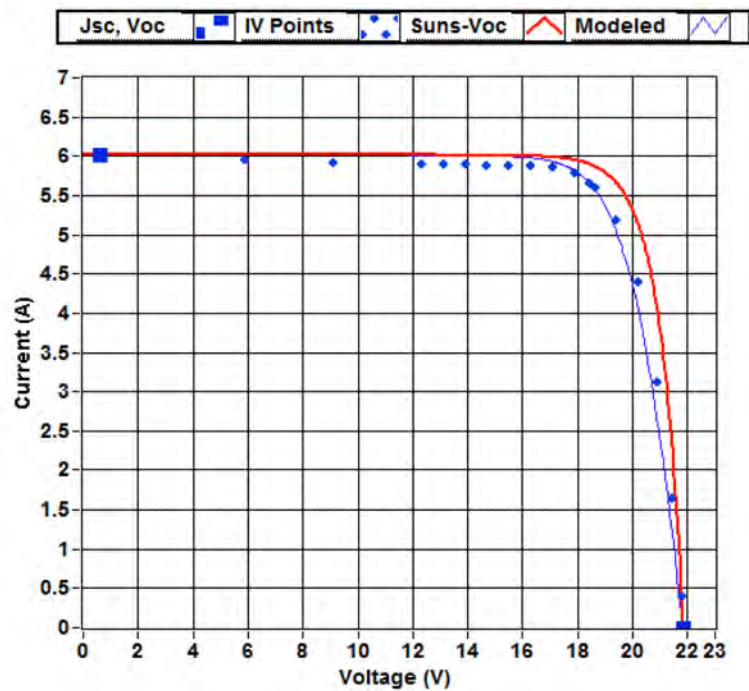
SOLBIAN SP100 EL TEST & FLASH TEST

Some minor micro-cracks in the bottom-middle cell. Compare Fill Factor and especially Rsh.

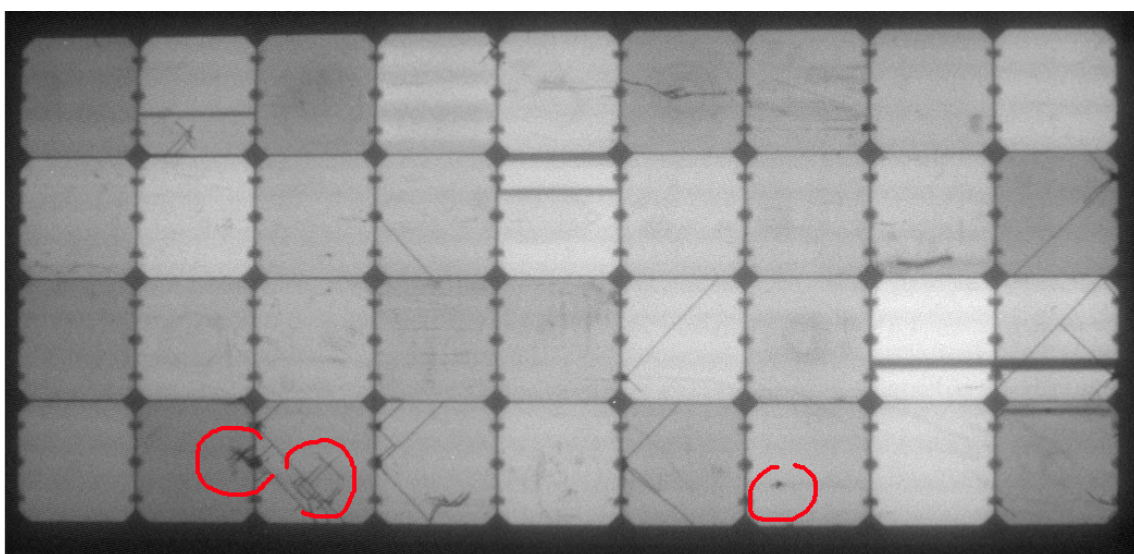
PV 125_1 after bending shows some increase of cracks (marked in red)

PV125_1	Before	After
Pmax	115,4 W	112,9 W
Fill Factor	76,0 %	75,3 %

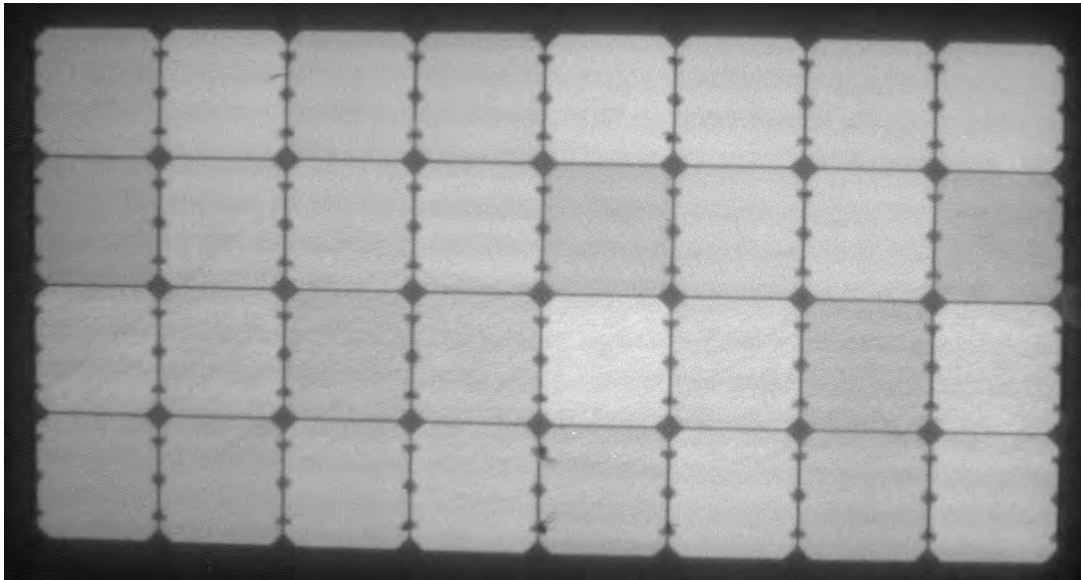
SP100 after bending shows no change

SP100	Before	After
Pmax	104,5 W	103,6 W
Fill factor	79,4 %	78,9 %

Some comment: the Sun Simulator accuracy is about 1%. This means that the values of electrical parameters before and after the bending, for the SP100 are "the same" under the instrumental accuracy.
